A 30-year-old diesel tank: fungal-dominated biofilms cause local corrosion of galvanised steel

The increased use of biodiesel is expected to lead to more microbial corrosion, fouling and fuel degradation issues. In this context, we have analysed the metal, fuel and microbiology of a fouled diesel tank which had been in service for over 30 years. The fuel itself, a B7 biodiesel blend, was not degraded, and—although no free water phase was visible—contained a water content of ~60 ppm. The microbial community was dominated by the fungus *Amorphotheca resiniae*, which formed thick, patchy biofilms on the tank bottom and walls. The tank sheets, composed of galvanised carbon steel, were locally corroded underneath the biofilms, up to a depth of a third of the sheet thickness. On the biofilm-free surfaces, Zn coatings could still be observed. Taken together, *A. resiniae* was shown to thrive in these water-poor conditions, likely enhancing corrosion through the removal of the protective Zn coatings.

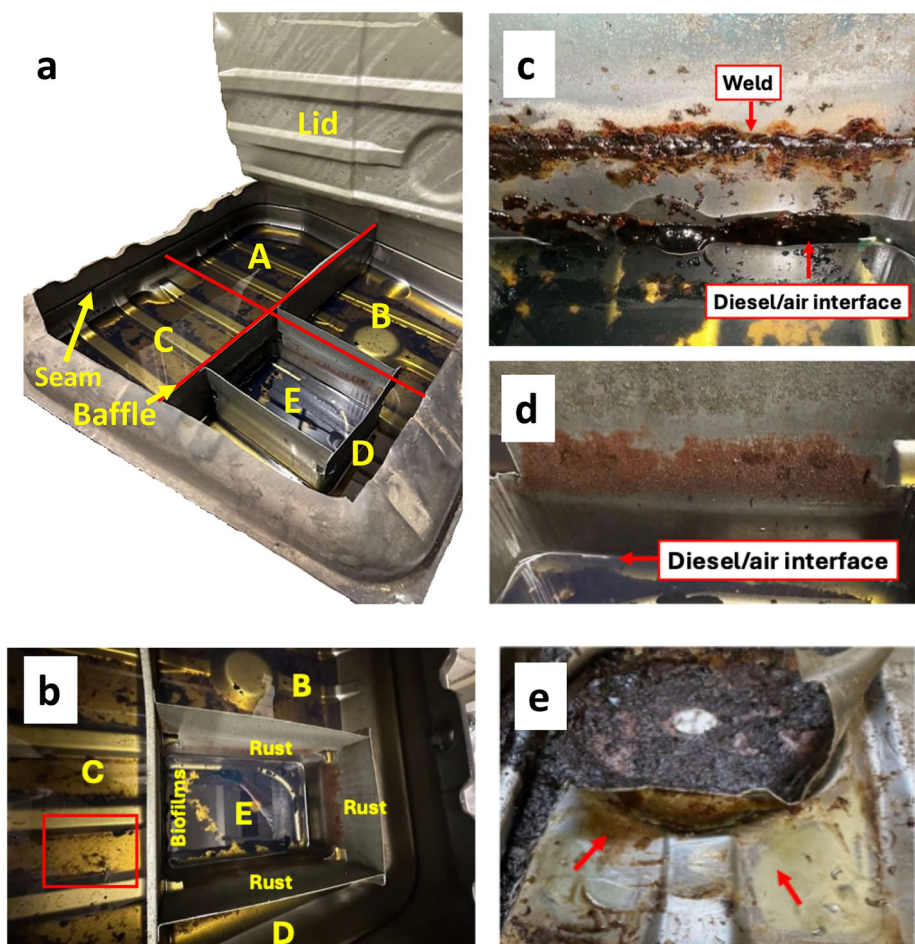
Fig. 1 | Photos of the opened diesel tank and select components that were analysed in this study. **a** An overview of the opened tank, showing the arbitrarily designated compartments, along with the lid, seam, and the baffle that were also subject to various analyses. **b** A top view of a portion of the tank highlighting the features of compartment E. In addition, the red boxed area in compartment C is an example of the brown flocs seen throughout the bottom of the tank. **c** A close-up view of the biofilms observed in compartment E; the deposits at the weld are referred to as the upper biofilm in E, while the deposits at the diesel/air interface is called the lower biofilm in E. **d** An example of one of the rust areas observed in compartment E. **e** Brown and pale-yellow deposits observed underneath compartment E following the dismantling of the tank (referred to as underneath E).

Upon opening the tank, brown biofilm-like deposits were visible in each compartment of the tank that were either floating in the diesel (flocs) or attached to the steel sheets at the bottom and walls (above and below the diesel level). Samples collected from the biofilms and rust layers evident in compartment E, along with the lid, under compartment section E, the seam in compartment C, and the diesel itself (Fig. 1) were analysed by amplicon sequencing targeting a portion of the 16S rRNA gene for prokaryotes (V4-V5 region) and the ITS2 region for fungal identification.

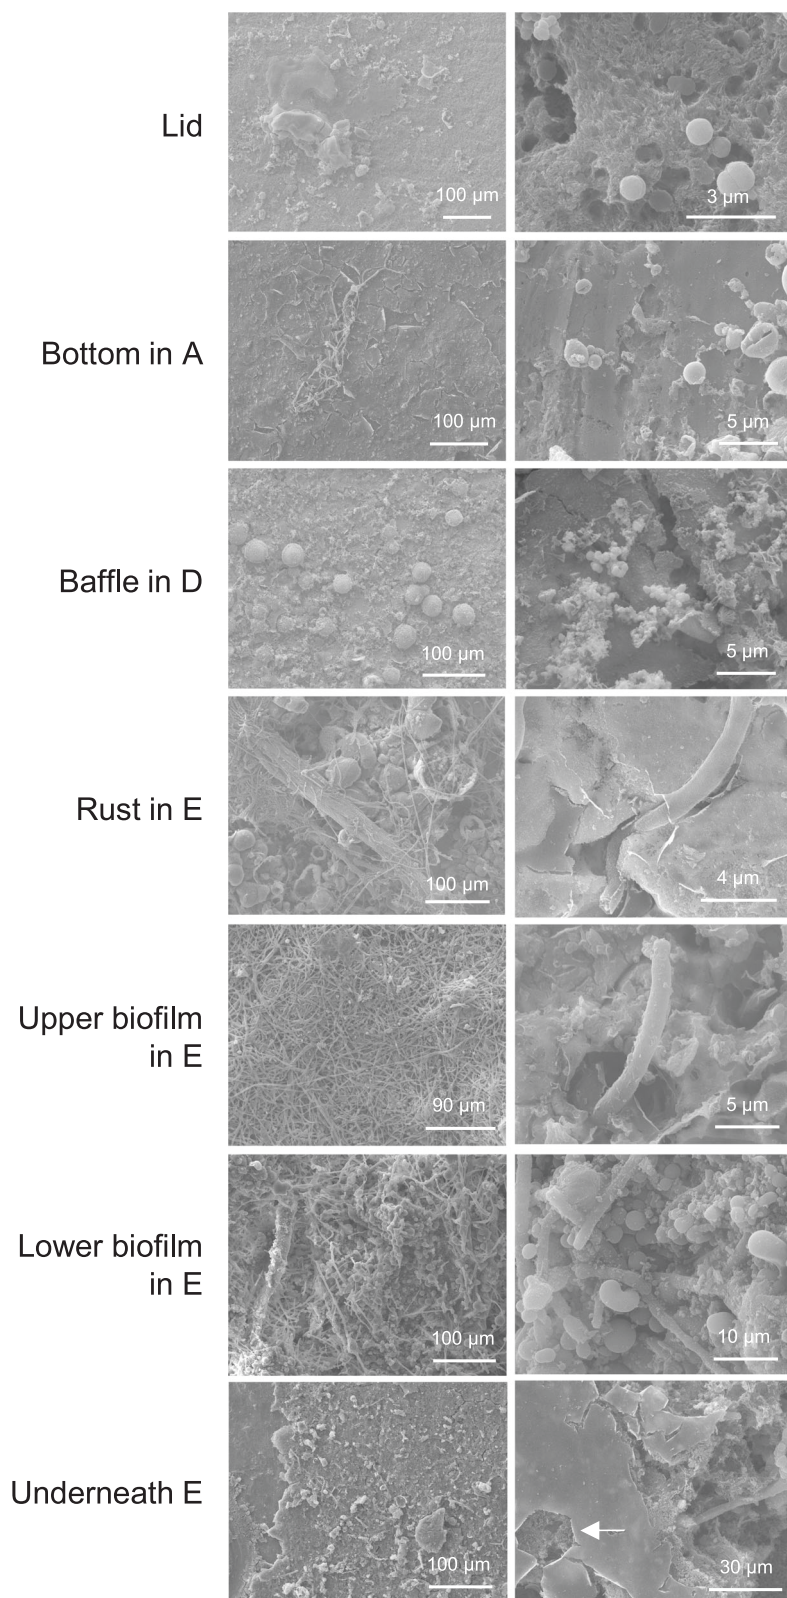
Fig. 3 | ESEM images of samples taken from different locations of the diesel tank. The lid, bottom in A and baffle in D were mostly covered by spherical cells and larger (30 μm in diameter) round cellular structures. The rust in E was composed of large, roundish structures and filamentous fungi. The upper and lower biofilms were composed almost entirely of filamentous fungi together with larger, roundish structures. Underneath E, the hexagonal, wurtzite structures (indicated by the white arrow) are typical of Zn oxides. See Supplementary Fig. 4 for additional SEM images and Supplementary Fig. 5 for EDX analyses.

covered with an abundance of fungal hyphae and spherical cells which were notably larger in size than most prokaryotic cells (e.g., larger than 1–2 μm) (Fig. 3), confirming the dominance of fungal biomass in these biofilms and rusty areas. As well observed within the biofilms and on the rust in E sample were large, smooth, roundish structures with diameters ranging from 50 μm to 1 mm (Supplementary Fig. 4). The floating flocs were also mostly

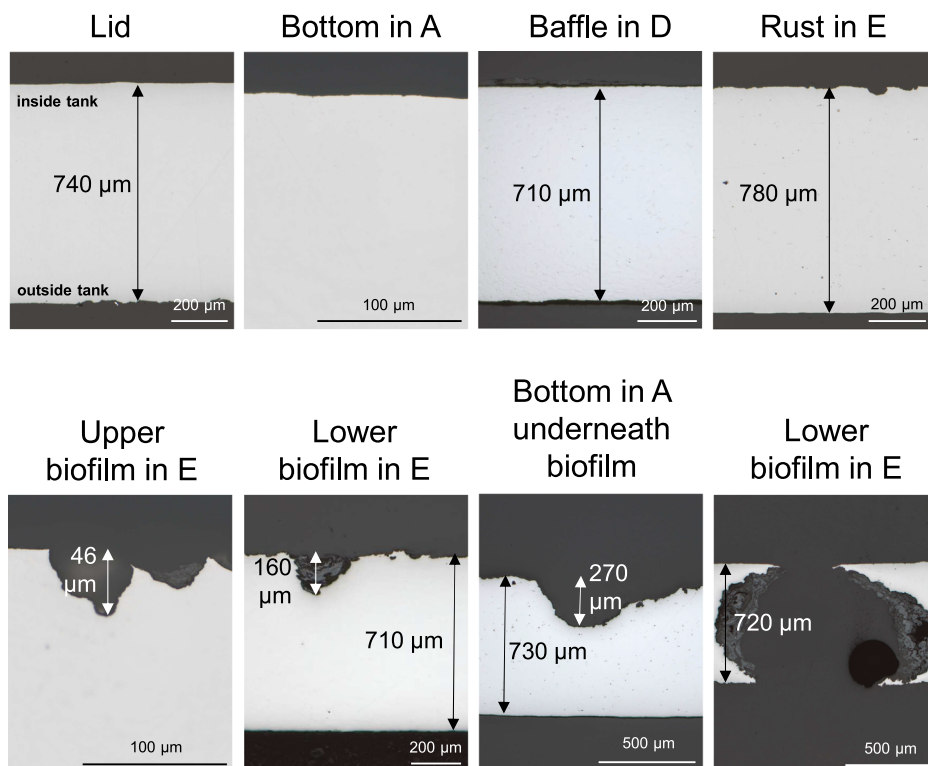
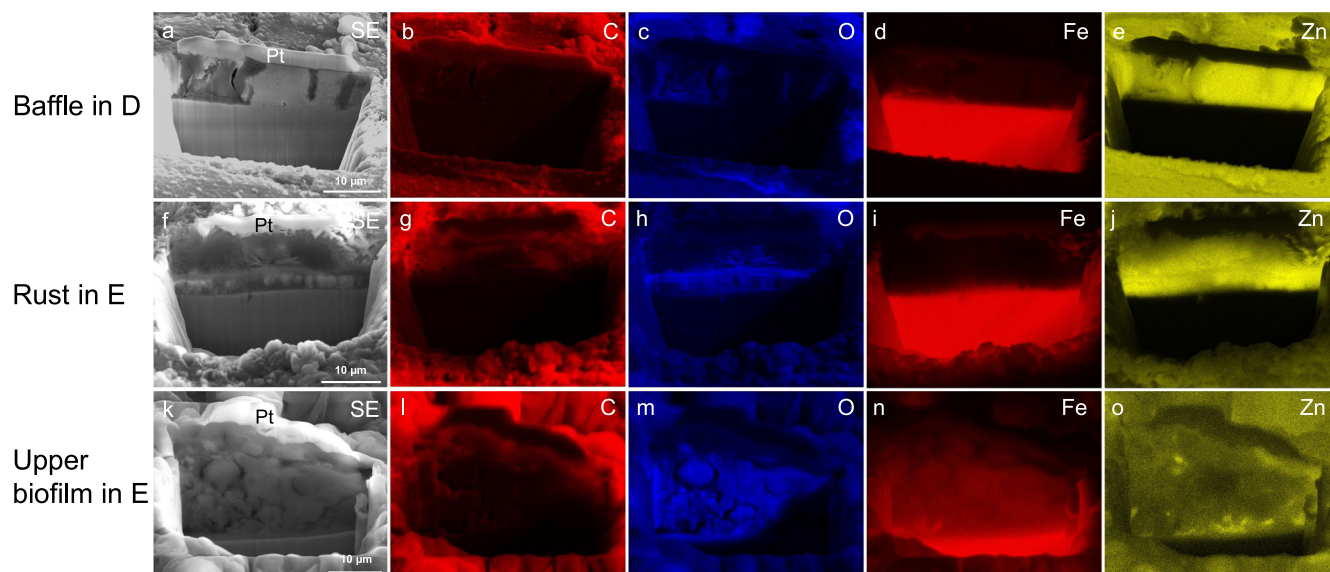
Fig. 4 | Analysis of the carbon steel cross-section using metallography. Samples were embedded in resin, cut, and analysed via microscopy. This analysis not only gave an exact depth of the localised corrosion features but also the thickness of the steel plate. The shown sample from underneath the lower biofilm (bottom, right) was taken from a piece of bent steel, allowing colonisation on both sides, likely explaining the hole through the steel.

metallography analyses showed pits underneath the biofilm, but the depth of these was larger for the latter method, as interferometry does not allow the detection of the pit bottom of deeper pits. We therefore only discuss the depth of the pits observed by metallography. These results showed that up to 36% of the steel sheet was removed underneath biofilms (Fig. 4). Moreover, this observation was independent of the location, as it was done for biofilms grown in the main tank (compartment A) and in the fuel gauge compartment (E). Note that we do not take into account the hole observed in the

bent, inner sheet underneath the lower biofilm (Fig. 4) as we hypothesize that it was caused by the presence of fungal biofilms on both sides of the sheet. As the tank was in use for over 30 years, this is a case of modest microbiologically influenced corrosion (MIC). Some observations were nevertheless unexpected and need further discussion.
