More than heavy rain turning into fast-flowing water – a landscape perspective on the 2021 Eifel floods

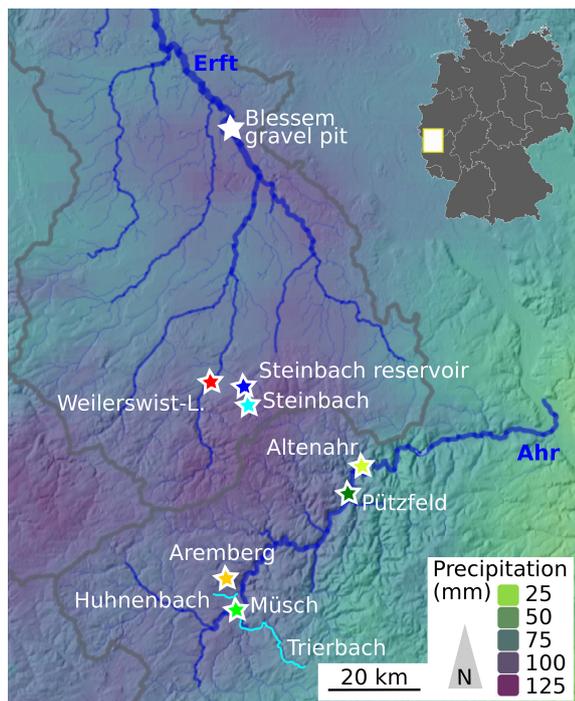
Figure 1. Map of the affected area with 3 d precipitation accumulated for 12–15 July 2021 from RADOLAN data (Radargestützte Niederschlagsanalyse und -vorhersage; CDC, 2022). Stars indicate locations of pictures of other figures in this article. Light-blue lines depict rivers of special interest mentioned in the text. Background map shows two of the most affected river systems, Erft and Ahr (line width indicating stream order), on top of a hillshade and slope map. Inset shows the location of the map within Germany.

susceptibility to gravitational mass movement in this landscape, except for steep landforms that predominantly result from man-made construction (e.g. road escarpments, waste dumps, open-pit mining; cf. Fig. 1). Both regions hold a long legacy of human land use.

According to Fig. 1 based on radar and station observations (RADOLAN data set; Weigl and Winterath, 2009) the precipitation amount for the 72 h period of 12–15 July at Weilerswist-Lommersum is similar to the amount observed in Blessem (Fig. 1). Moreover, the time series at the selected station is sufficiently long for the calculation of robust IDF curves (daily precipitation is available since 1905, as well as hourly precipitation since 2004). The analysis confirms the unusual extreme character of the precipitation amounts during the July event (black lines and crosses in Fig. 2). Sub-daily as well as daily and multi-day amounts exceeded the values corresponding to a 500-year return period determined under the assumption of stationary climate conditions.

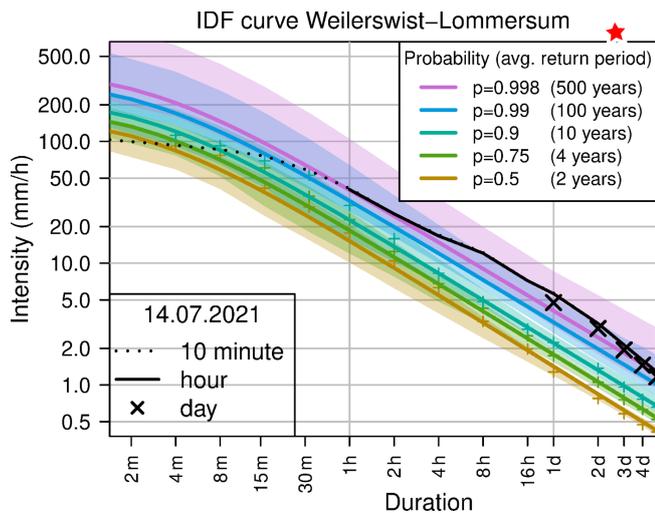
Figure 2. IDF curve for the weather station Weilerswist-Lommersum. Observations of 14 July precipitation are added in black based on different measurement intervals. Coloured lines depict different non-exceedance probabilities; respective shadings indicate 90 % confidence intervals.

Nevertheless, we are able to constrain the antecedent conditions; driver mechanisms; and, to some extent, the impacts of the flood event based on instrumental data. Spatially resolved precipitation information (Weigl and Winterath, 2009; CDC, 2022) such as 1 km² gridded hourly data is stacked as 72 h sums throughout the main event duration (12–15 July 2021). In addition, instrumental station data (CDC, 2022) of representative sites were used to characterise the severity of the rain event. We fitted intensity–duration–frequency (IDF) curves to historical annual maximum precipitation measurements. The IDF model was fitted with the extended consistent quantile estimation method (Fauer et al., 2021) and evaluated for the DWD station Weilerswist-Lommersum (Fig. 2).

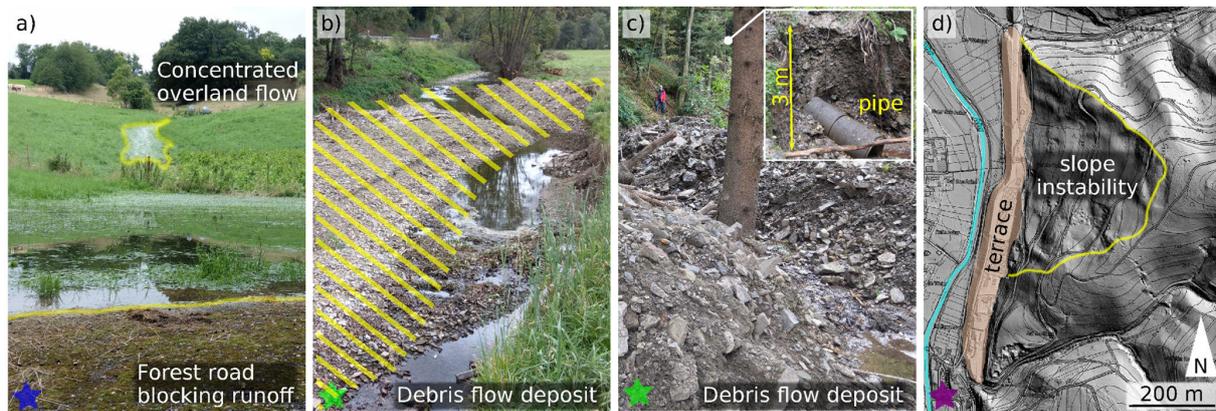
Figure 3. Landscape features emerging from the flood. For locations of these pictures, see star signatures in Fig. 1. (a) Focussed discharge along the hillslope causing deep and fast flow and thus efficient drainage in the background. However, the provided water is not routed downslope in the foreground but ponded by infrastructure and released at selected spots with increased erosive stream power. (b) Deposition area of the debris flow shown in panel (c), injecting massive debris into the main channel (Trierbach), temporally blocking the stream and causing severe reorganisation of the hydraulic geometry. (c) Lateral deposits of the debris flow at the end of the valley-confined section. Inset shows upstream knickpoint formed by overspill and erosion of clogged drainage pipe (50 cm diameter). (d) Old slope instability (yellow line) above a 20 m high engineered terrace with industrial infrastructure on it. The terrace just east of the town of Antweiler had been undercut by the Ahr River during the flood.

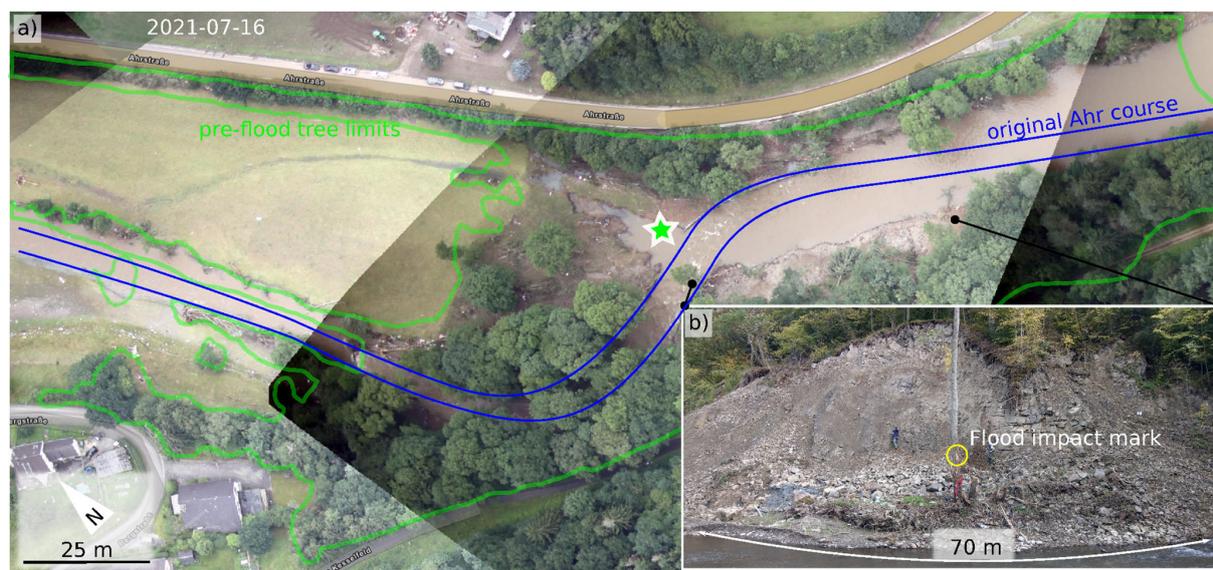
Figure 4. Debris mobilisation features in the Ahr valley near Müsch (cf. Fig. 1). Aerial image (BBK-DLR, 2022) taken 1 d after the flood. The light-green outline depicts the tree limit before the flood. Blue lines illustrate the pre-flood course of the Ahr River. **(b)** View from the green star in panel **(a)** towards the eroded right bank, which had activated a 16 m high rockslide (persons for scale). Note flood impact mark on a remaining tree at 5 m above current water level. Please note that the date format used in this figure is year-month-day.

inorganic debris from the stream bed (Fig. 4b) onto the floodplain. Also fine material was deposited in front of woody debris obstacles (Fig. 5c) and clogged anthropogenic structures, such as bridges. This readily available fine material is now a temporary source for increased fluvial sediment flux. Hence, even low-intensity floods will be able to carry comparably high concentrations of sediment particles. In contrast, the ejected coarse bed particles are currently removed from the fluvial domain until future bank erosion (or human land use practice) reincorporates them to the channel. Debris also resulted in permanent alterations to stream courses, due to lateral and vertical erosion, and in some steep channel reaches even led to incision into the underlying weathered bedrock as mapped out systematically in headwater reaches. This again resulted in undercutting of the banks and local landslides. The spatial reorganisation of sediment in the fluvial domain as well as overall changes in river geometry and bed properties – from small creeks a few kilometres past the watershed to major rivers like the Ahr – inevitably caused a transient in the catchment reaction to future floods.

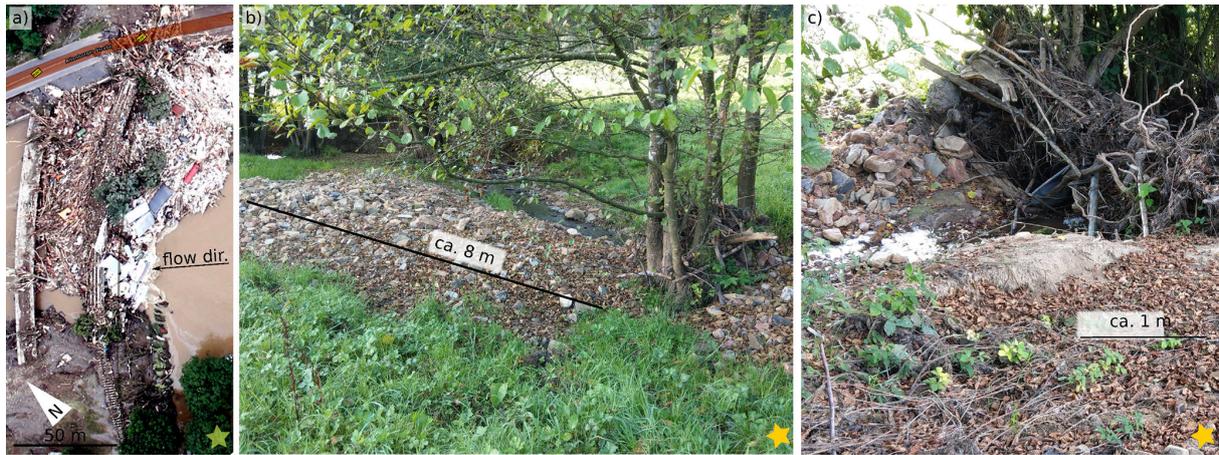
Figure 5. Effects of large woody debris. For locations on wider map see stars in Fig. 1. Pair of clogged bridges near Altenahr, bypassed along the left and right bank. Note the bipartition of the collected debris with woody material caught by the downstream road bridge and anthropogenic debris collected later by the upstream railway bridge. Note two remaining standing trees in the river depicting the width of the Ahr River before the flood. Aerial image by BBK-DLR (2022). **(b)** Huhnenbach near Aremberg about 2 km from its source (see Fig. 1). Note clogging by woody debris at riparian trees and the resulting ejection of coarse bed material out of the channel. **(c)** Another clogging of the Huhnenbach some 20 m upstream of panel **(b)**, with both ejected coarse debris and deposition of fine sediments in front of the obstacle.

The subsequent transport of large woody debris through the river channels had a series of effects (Jochner et al., 2015; Okamoto et al., 2020). In the main streams, clogging of obstacles, mostly bridges, resulted in temporary ponding and

backwater effects (Fig. 5a). As a consequence, upstream water levels rose, and the inundated areas grew until the obstacle was either bypassed, overtopped, or destroyed. In the former case, the bypass location experienced increased flow velocity and thus bed shear stress, resulting in focussed erosion. The latter effect has the potential to generate a pulse of water travelling downstream like an outburst flood. Given the presence of many such obstacles along the course of the Ahr valley (62 out of 75 bridges destroyed) and most likely other streams draining the Eifel, the failure of obstacles most likely contributed to non-linear, pulsed hydrograph behaviour, as partly confirmed by affected people and experienced during earlier floods (Roggenkamp and Herget, 2022). However, the large spacing, insufficient time resolution (15 min sampling interval), and eventual failure of existing stream gauges prevent us from resolving this conceptualised hydrograph behaviour and its resulting inundation and shear stress pulses. The traces of these clogs are visible both in the main valleys (BBK-DLR, 2022) and in headwater regions, where we were able to map numerous blockages of first-order streams, either at anthropogenic structures (bridges, water passages, fences) or at narrows formed by riparian trees (Fig. 5b). In many reaches, these blockages were formed at a spacing of a few tens of metres, ponding backwater due to accumulation of organic fine material (Schalko et al., 2018) and implying significant effects already at very small contributing areas. The propagation of non-linear flow effects from small creeks to and throughout the trunk river of a catchment is a crucial step to take for successful future flood impact anticipation.

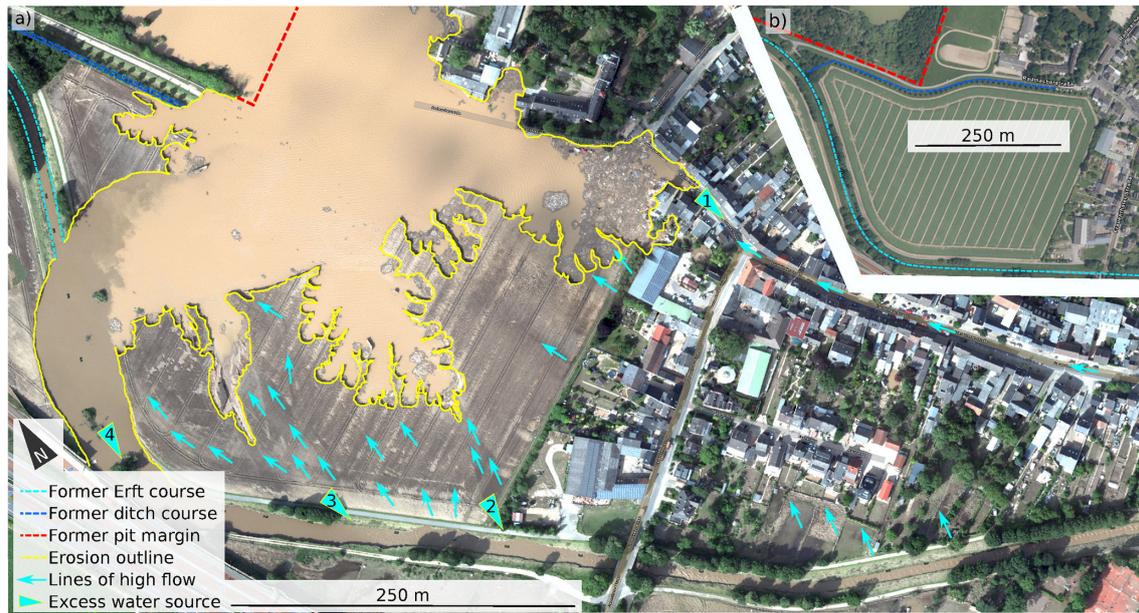
Figure 6. Aerial image (BBK-DLR, 2022) of the town of Blessem. **(a)** Situation shortly after the flood event, with annotated features. The top-right inset **(b)** shows conditions before the flood. The break in slope along the margin of a gravel pit (red dashed line) had started to erode towards the town by fluvial erosion (yellow line) that formed three individual clusters. The erosion was fuelled by overbank discharge of the Erft River, evading the town of Blessem and moving down the main street, as well as water flowing over the field west of the town margin, following the line of steepest descent. Water flow directions are indicated by blue arrows where visible from aerial imagery. The four numbered blue triangles depict sites of increased water input towards the pit.

At a comparably small scale, the town of Blessem on the Erft River was subject to such an emerging landscape connectivity case. The excess rainwater of Blessem was collected and channelised in pipes below the main road (Frauenthaler Straße, then passed to Radmacherstraße). These pipes ended in a drainage ditch at the western town limit that routed the water towards the Erft River (Fig. 6b), passing by a gravel pit that was protected by a rampart a few metres high. During the flood, overbank discharge of the Erft River moved water across the main streets of Blessem (light-blue arrows in Fig. 6) and not only injected excess discharge into the drainage pipes but also ran as overland flow along the streets. In addition, Erft overbank discharge was routed over a field west of the town, towards the drainage ditch already carrying the town's excess water. Whether that excess water caused overspilling of the 2 m deep drainage ditch or if the additional water inflow from the field caused the overspill cannot be resolved here. Regardless, the ditch overtopped and discharge followed the line of steepest descent into the gravel pit, whose protection rampart was not fully closed but had a

gap through which the water could enter the pit. As the flow path gradient changed from less than 1 to about 20° down the pit slope, the shear stress increased by 2 orders of magnitude (Anderson and Anderson, 2010). This high shear stress, combined with the high erodibility of the underlying material (a thin loess cover on tertiary Rhine gravel), resulted in extremely rapid erosion and the development of an erosional margin (yellow line in Fig. 5) that cut backwards by about 250 m within a few hours. The final shape of the erosional margin shows four discrete tongues of enhanced slope retreat (cf. numbered triangles in Fig. 6), which correspond to the main sources of excess water: the road and drainage pipes running through the town of Blessem (triangle 1); two over-flow spots of the Erft River across the field at the edge of the town (triangles 2 and 3); and ultimately, the river Erft itself (triangle 4), which routed its whole discharge into the eroded gravel pit. This led to rapid inundation of the pit, massive deposition of > 450 000 m³ of material, enhanced lateral erosion along the (new) outer bank of the diverted river, and significant depth erosion not only of the new course of the Erft River but also in its old bed, forming a knickzone and resulting in a bed elevation lowering of 1.4–1.8 m.

Despite initial media reports of a landslide (i.e. a gravitational mass-wasting process) happening near Blessem, all evidence rather implies that it actually was a process driven by flowing water. That process in turn was the result of a local process connection mechanism: backward erosion of the gravel pit margin. At the same time, the mechanism was also controlled by emerging feedbacks, i.e. the reduction in backward erosion by cessation of overbank discharge through base level lowering of the Erft River as it flowed into the gravel pit. Hence, what happened in Blessem is an example of how geomorphic processes first amplified and later counteracted the impact of a hydrological extreme event.
