A 30-year-old diesel tank: fungal-dominated biofilms cause local corrosion of galvanised steel

The increased use of biodiesel is expected to lead to more microbial corrosion, fouling and fuel degradation issues. In this context, we have analysed the metal, fuel and microbiology of a fouled diesel tank which had been in service for over 30 years. The fuel itself, a B7 biodiesel blend, was not degraded, and—although no free water phase was visible—contained a water content of ~60 ppm. The microbial community was dominated by the fungus *Amorphotheca resiniae*, which formed thick, patchy biofilms on the tank bottom and walls. The tank sheets, composed of galvanised carbon steel, were locally corroded underneath the biofilms, up to a depth of a third of the sheet thickness. On the biofilm-free surfaces, Zn coatings could still be observed. Taken together, *A. resiniae* was shown to thrive in these water-poor conditions, likely enhancing corrosion through the removal of the protective Zn coatings.

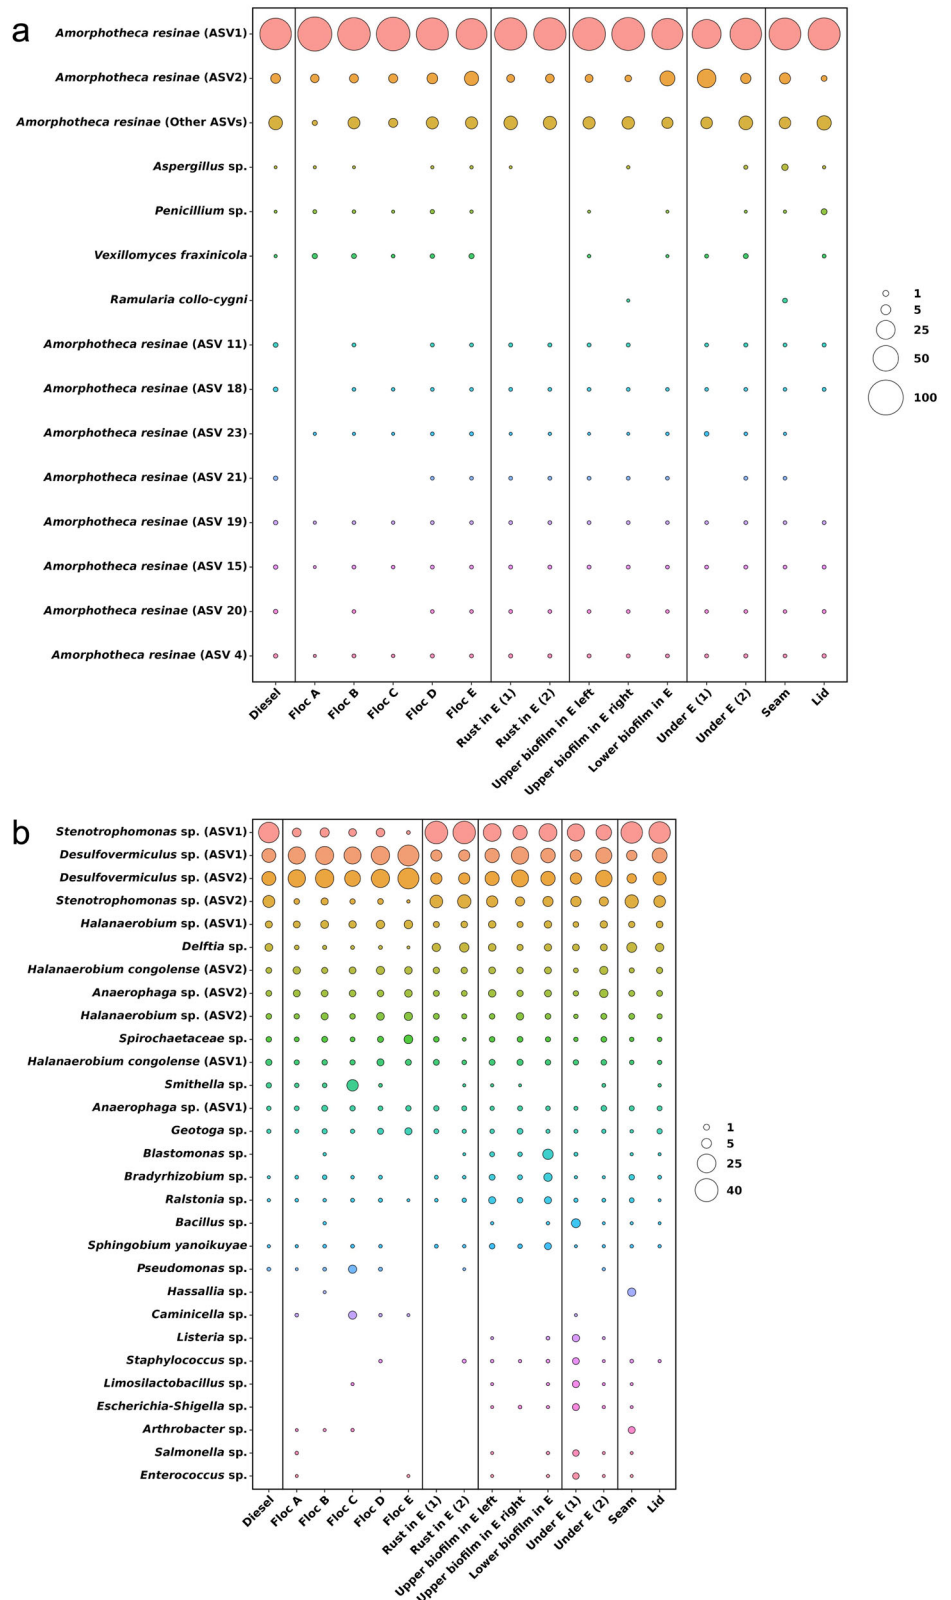
The 2025 fungal community was dominated by multiple ASVs of *A. resiniae* (Fig. 2a), similar to the 2021 and 2022 communities. One *A. resiniae* ASV was dominant across all samples, ranging from 66 to 95% relative abundance of the fungal sequences obtained. A second *A. resiniae* ASV made up the second most abundant fungal taxon, ranging from 1% (lid) to 25% (under E) relative abundance. Many other ASVs identified as *A. resiniae* were also present in the sample. Those that were present in the top 10 most abundant taxa (and occurred at greater than 0.25% relative abundance in at least one sample) are shown as individual ASVs, with all others grouped together as ‘other ASVs’ of *A. resiniae* (Fig. 2a). Although many of the other *A. resiniae* ASVs were individually present in low relative abundances (<1%), this result shows the diversity within this species under these conditions and aligns with the results of Gerrits et al. (under review) who readily isolated three distinct *A. resiniae* strains from this diesel tank. It should be noted, however, that the dominance of *A. resiniae* (and multiple ASVs associated with this taxon) could be due to primer and sequencing biases, which are well-known limitations of amplicon sequencing⁴⁰. Other fungi present at

Figure 2b presents a summary of the prokaryotic taxa found in all 2025 diesel tank samples. The 10 most abundant taxa for each sample are shown. As with 2021 and 22 samples (Supplementary Fig. 1c), many bacterial taxa were identified, with a decided overlap to previous communities. Notably, ASVs identified as *Stenotrophomonas* and *Desulfovermiculus* were most abundant in the majority of samples, with several other aerobes and anaerobes (including more than one ASV of *Anaerophaga* and *Halanaerobium*) contributing to community structure. Samples taken from loose flocs appeared to contain lower relative abundances of *Stenotrophomonas* but overall were comprised of most of the similar taxa as other samples. Beta diversity analysis (shown as a non-metric multi-dimensional scaling (NMDS) plot in Supplementary Fig. 3) showed some clustering of the loose floc communities, separated from the attached biofilm communities, which also grouped closer to one another. Samples collected and processed in duplicate (such as rust in E) grouped closely in the NMDS analysis.

Fig. 2 | Microbial community sequencing results of diesel tank samples. Bubble plots showing the results of **a** ITS (eukaryotes) and **b** 16S rRNA (prokaryotes) gene sequencing of samples collected from various sections of the diesel tank in 2025. The size of the bubbles represents the relative abundances (%) in each sample. The plots were generated based on the top 10 highest relative abundances of ASVs in each sample. For the ITS results, '*A. resiniae*' other ASVs ' contains ASVs that were present at <0.25% relative abundance that were grouped together; numbered '*A. resiniae*' shown are those present at 0.25% relative abundance or greater. Samples rust in E, upper biofilm in E, and under E (underneath E) were sampled and processed in duplicate thus are shown as different samples.
